MedSun Newsletter #62, July 2011

Highlighted MedSun Reports

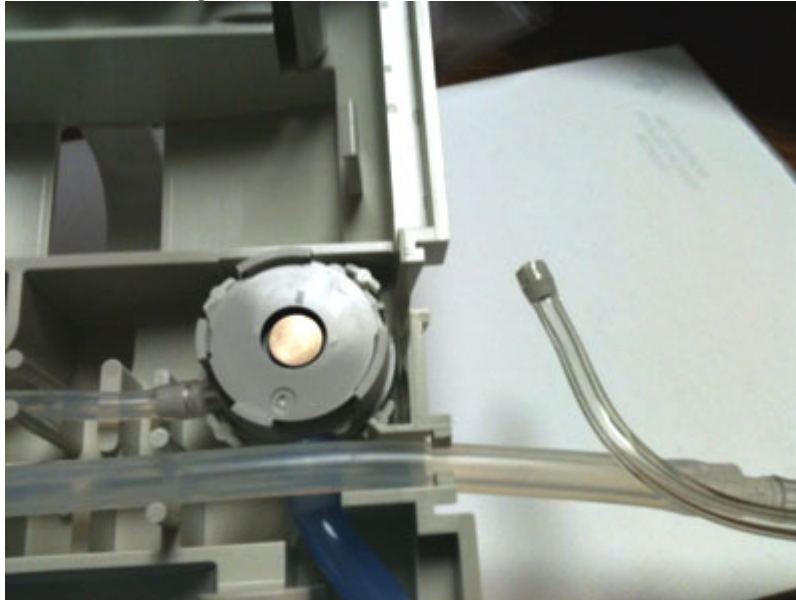
Nurse was setting up and priming set; observed that tubing was not connected correctly to cassette. Examination revealed that small rigid plastic connection port was broken. Nurse requested another set which was connected properly and which primed properly. Case proceeded. Slight delay in set-up time resulted. No adverse event. Note that this event happened twice on the same day - i.e. for two separate IOL cases.

OR reports that this is a low frequency but recurring event. They estimate that this is happening about 6 times per 1000 IOL cases. Unable to determine if this is a defect in manufacturing or if this suggests a need for better in-service of staff. Digital photographs of defective device have been sent to MedSun.

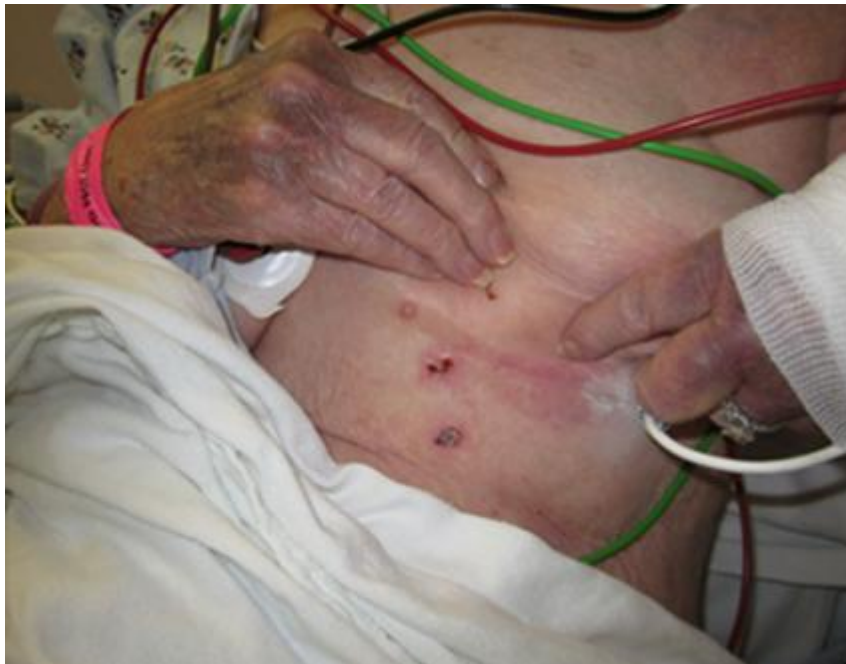
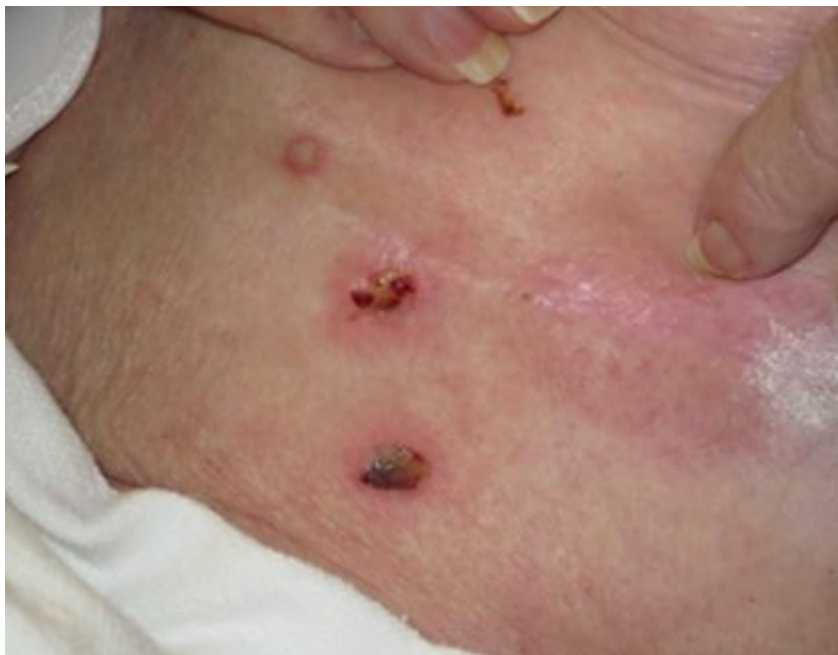
Photographs of patient burns, such as the ones described in some of the reports included in this summary appear below:
